# Manhole Inspection Summary

Manhole # S39EE\_031MH

Insp Date: **1/9/08 1:25 PM**

**Location** Address: **1101 E CHASE ST**

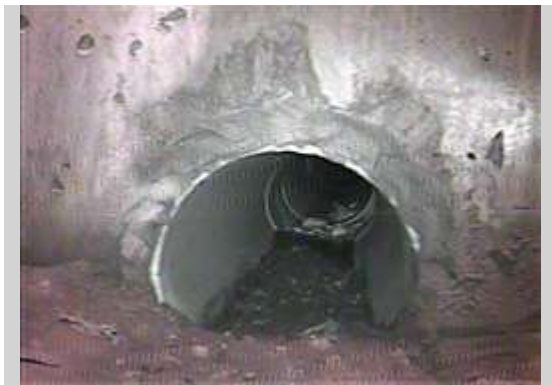
12 O'Clock Outflow

8 in. Circular Gravity Sewer  
Pipe Out @ 12 O'Clock

Pipe Material: **PVC** ☐ Pipe Lined

Infiltration: **None** Pipe Seal Cond: **Sound**
